August 16, 2019

Re: BRM-00255020-A0 Hydrogeological Review - Bacher Construction Ltd. - Pit and Quarry  
Township of Algonquin Highlands, Haliburton County, Ontario

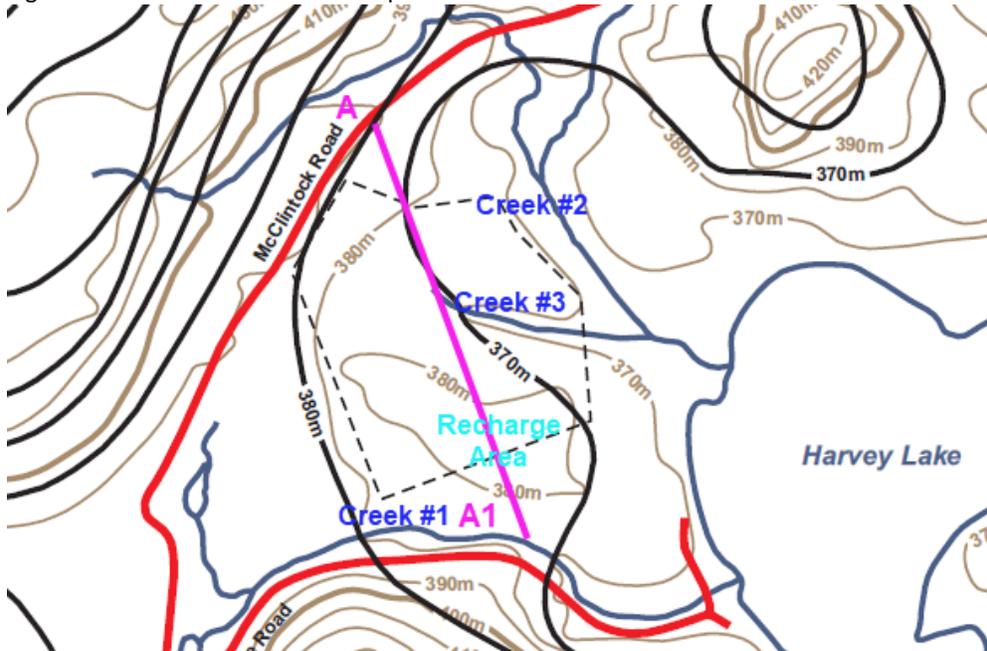
Figure B. Groundwater Contour Map

A groundwater contour map for the site was presented on Figure 4 by Waters Environmental Geoscience Ltd. (2016), hereinafter referred to as Waters. A detail of Figure 4 is shown on the appended Figure B.

On Figure 4 of the statement, water levels are sketchily presented with 10 m interval contours, which according to Waters are interpreted to represent the highest groundwater conditions onsite. So far, the site lacks field evidence to characterize it properly, as there are no onsite monitoring wells. To EXP's knowledge, groundwater levels were not measured onsite by Waters and no monitoring program of water levels has been implemented, and no well water well records are reported within 1 km of the study area. Therefore, the claim that Figure 4 of the Waters report is representative of highest groundwater levels cannot be supported. To provide such information, onsite monitoring wells are required, and multi-year seasonal groundwater level monitoring is needed.

For that reason, EXP disagrees with the stated interpretation (representation of highest groundwater conditions), as seasonal groundwater fluctuations and especially high-water levels during spring thaw (freshet) are yet unknown. The document by Waters (2016) rightly claims to be a "Groundwater Summary Statement", which is not a detailed hydrogeological report.

The groundwater contours shown on Figure B suggest discharging conditions to creeks #1 (south) and #3 (center) and recharging conditions between these streams. The assumed horizontal water table in cross-section A-A1 of the final Site Plan by Timber Craft Consultation Inc. (2019), as depicted on Figure C, is inconsistent with the interpretation made by Waters (2016). Generally, under current recharge conditions, the groundwater surface would somewhat mirror the surface topography for low hydraulic conductivity soils/rocks, and it would flatten, if the hydraulic conductivities are high.

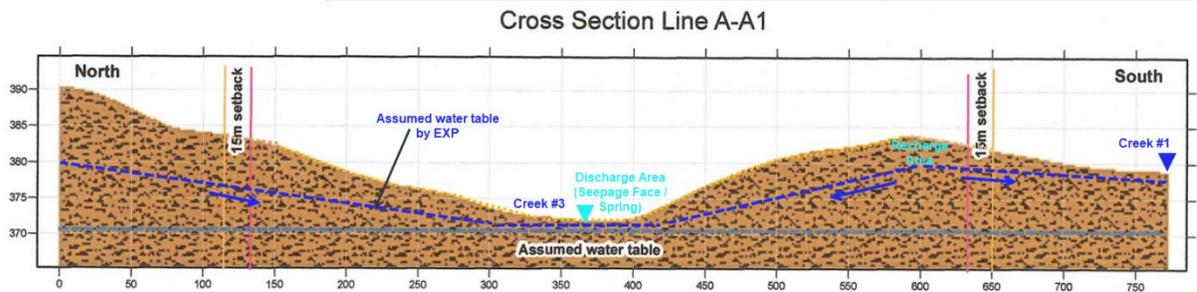
Figure C. Assumed Water Table in Cross-Section A-A1

According to cross-section A-A1 presented on page # 2 of the Final Site Plan by Timber Craft Consultation Inc., there are no anticipated potential impacts shown on the horizontal water table. EXP's view on this prediction is that this seems a very unlikely and unrealistic scenario. EXP would expect an alteration of recharge areas and contribution to surface water features, potential effects on water quality (surface and groundwater), disruption of discharge areas and potential impacts on natural features, lowering of water table and changes in flow regime as likely outcomes of the extracting activity. Potential impacts due to the proposed pit/quarry development can be assessed with a detailed hydrogeological investigation.

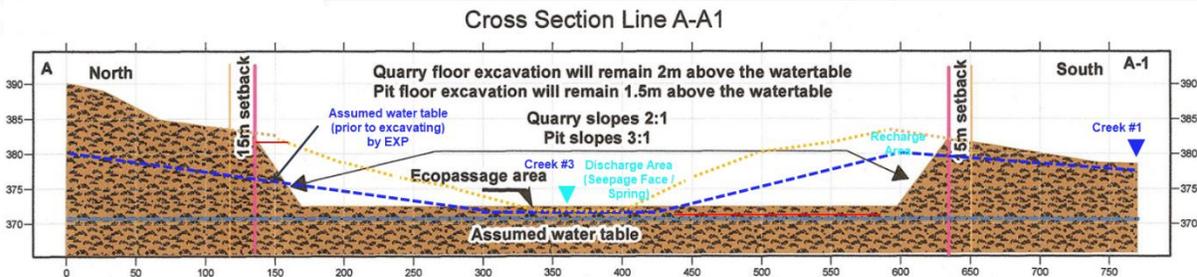
Figure D Assumed Excavation below the Water Table in Cross-Section A-A1

EXP, following the water levels interpretation made by Waters (2016), observes that the water table has relief (as depicted in Figure B) and accordingly, the proposed quarry floor is predicted to be below the water table, as shown on Figure D.

According to policy No. A.R.4.01.04, a minimum spacing of 2.0 m (and 1.5 m) needs to be maintained between the projected quarry (pit) floor and any static water level including seasonal high for bedrock (and overburden), respectively. Waters (2016) states that Bacher Construction Ltd. should avoid extracting bedrock below 382.0 masl in the northwest and 370.0 masl in the east. The elevation limit of 370.0 masl in the east is deemed as too low by EXP, based on surrounding elevation of surface water features, subject to actual field investigations.

EXP has the opinion that the proposed Site Plan by Timber Craft Consultation Inc. (2019) does not conform to the description "as above groundwater extraction of pit or quarry operation", and consequently, cannot be approved for a Category 9 or 11 application under the Aggregate Resources Act.
